## Hellenic Army Leopard 1 tanks

Hellenic Army Leopard 1 tanks LM35011

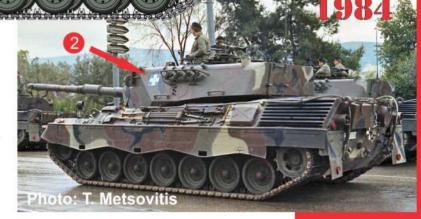
The position of all the markings was identical on all tanks, as seen on the photo to the right.

Army camouflage scheme based on the American MERDC camouflage scheme. The actual shades of the factory applied colours were quite different to the shades usually used by the Hellenic Army and the pattern was identical on all tanks. The brown was distinctly chocolate and the green had a grey tinge. These tanks retained their factory applied scheme for quite a few years, before being repainted in more "Greek" shades. The Greek colours are equivalent to FS37038 (black), FS34079 (forest green), FS 30118 (field drab and FS30277 (sand).

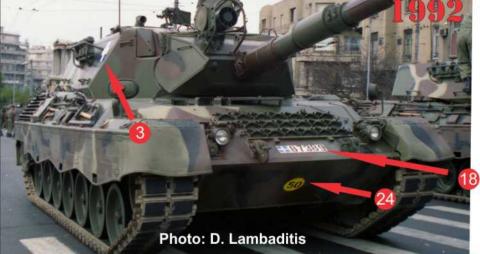
The national markings on the tanks in the 25th March 1992 parade were darker than previous years.

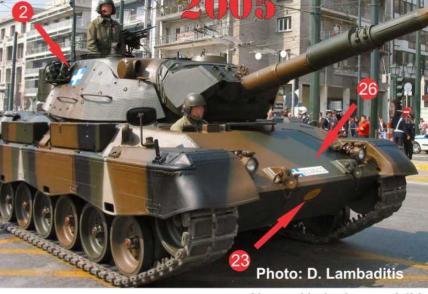
The rear number plate on the Leopard 1V was under the stowage box.

The circular Dutch marking that looks like a dog's head was present on the mantlets of many Leopard 1Vs.

The second Leopard type to enter service was the Leopard 1V in 1992. These were ex-Netherlands Army tanks that were surplus and transferred free of charge under the CFE Treaty. These tanks arrived in their Dutch dark green colour scheme, which they retained for a few years and Dutch markings. All Dutch national markings and number plates were painted over leaving a patchy finish, but some unit markings remained. The Dutch green finish was heavily stained and presented a multitude of different shades on various surfaces. Later these tanks were also repainted in the Greek four-colour camouflage.

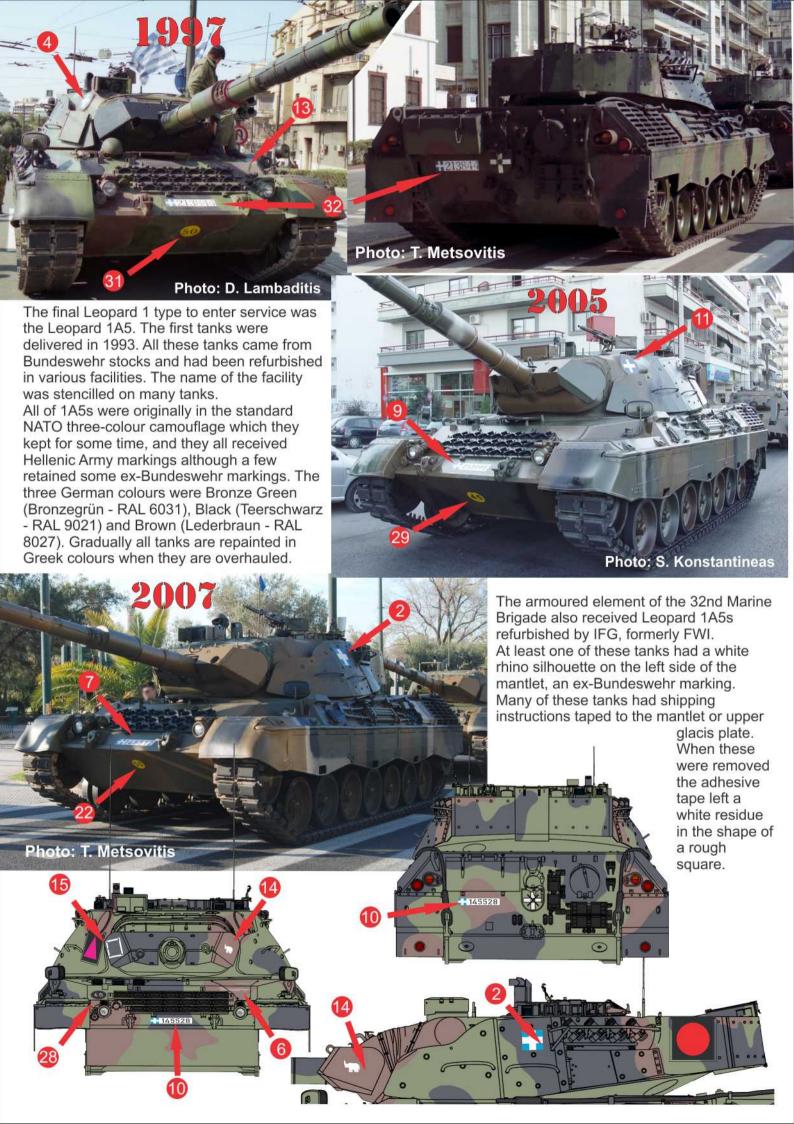
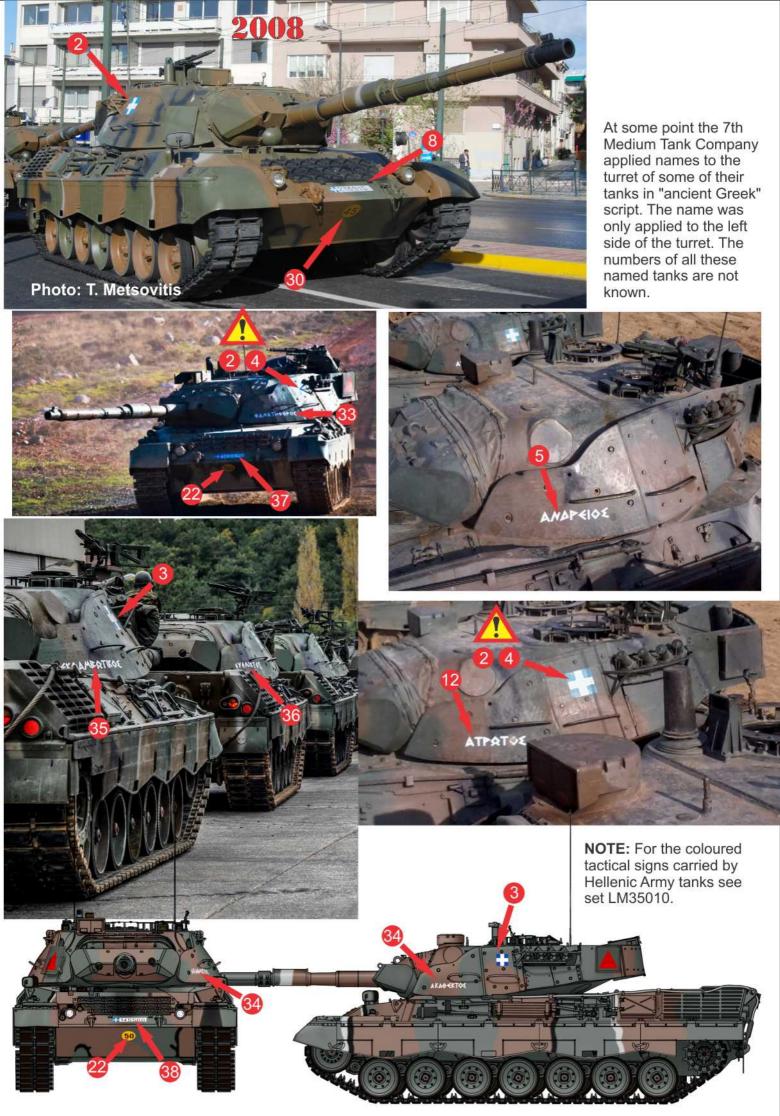
Along with the Leopard 1V the Hellenic Army received two unique prototype tanks. These were two Leopard 1Vs fitted with the EMES 18 fire control system like the German Leopard 1A5. The redundant protective cast thermal imaging collar was removed and replaced with a welded cover with a new rotating periscope for the loader. These two tanks, unlike the German ones, had stowage boxes on the hull sides just like the 1V. The Dutch smoke launchers were removed. Originally these tanks were delivered in the standard NATO three-

colour camouflage and received Hellenic Army markings. Later they were repainted in the Greek four-colour camouflage as seen here. The rear number plate on these tanks was again under the stowage box.
